**The Flanagan Corporation**

### **TRYST Water Feature – Wynn Casino**

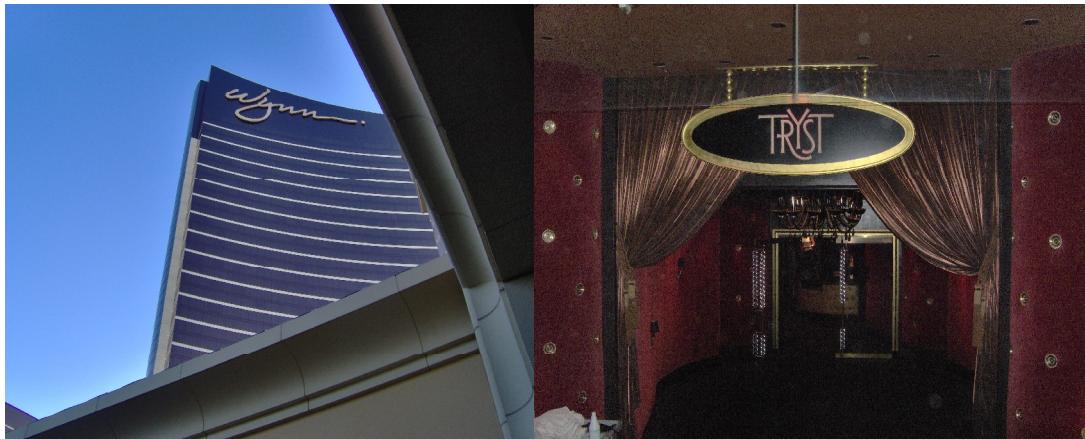
**Overview:** Can you imagine loosing more than 30,000 gallons of water a day! Well this is what the Wynn Las Vegas Casino said they were up against when they approached The Flanagan Corporation in consideration of the use of Polyurea's to solve their leaky problems. The water feature at the TRYST Nightclub is a main attraction for the club and down time was a critical problem. Since the night club generates as much as \$250,000 revenue a weekend it is no wonder this was of importance. One of the big challenges was the fact that it seems much of the leaking was coming from 4 weirs that cascade down to the main water feature. Behind the wall where the weirs were formed was a verity of electronics and occupied space that was critical to protect.

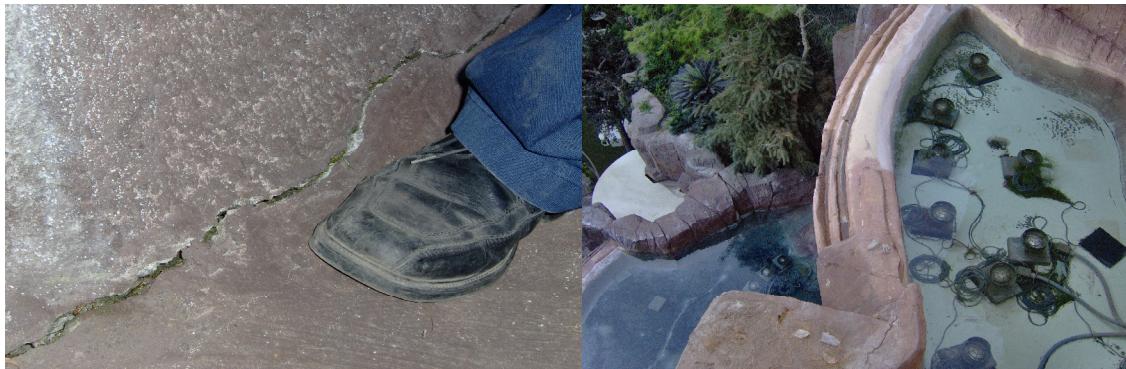
**Description:** This particular water feature had some very challenging issues that would need to be addressed. It was obvious that most of the leakage was from cracks that extended for several feet in each weir. We knew that when we drained the holding pools that it make take several days or even weeks for the water to stop seeping up from the cracks. Since down time was so critical and we only had 3 days to complete the project we had to come up with an engineering solution that would allow for us to coat over the wet cracks. In an effort to stop some of the water seepage we filled the cracks with a low viscosity epoxy with a fast set urethane gap fill system to form a dam. Next we would using some plastic pipe cut in half and attached over the crack leaving a place for the water to escape behind the Polyurea coating that we would install later.

We also were concerned with the water chemistry since chlorine and bromine were used. To avoid premature failure of the Polyurea (High Chemical System) we used a Fluoropolymer as a top coat. This would also give us UV resistance that was also desired.

**Products:** A 2 part fast set polyurethane primer was selected for the priming of the concrete. Next we used a High Chemical Resistant Polyurea system to help with any potential exposure issues incase of top coat failure. As a top coat we selected a Fluoropolymer system to avoid premature failure caused from the Chlorine and Bromine that was used to keep the water clean. The Fluoropolymer would also give us the UV resistance that was required by the customer.

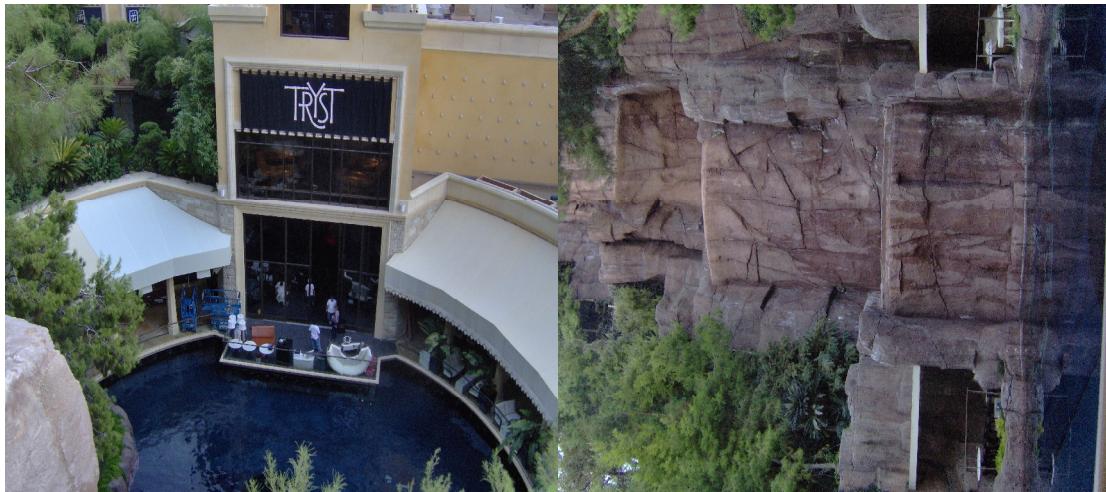
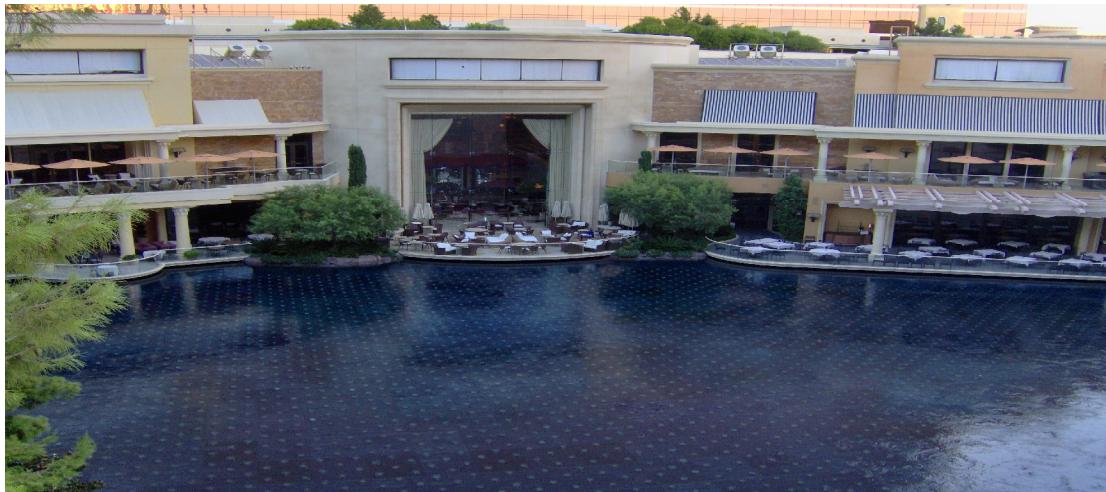
**Results:** The results of the coating selection were a success. Today they are seeing a drastic drop in the daily water loss and noticing less and less leaking into the occupied space behind the weirs. Because of the success they are not considering the same application for various other water features that are in a similar situation.
